REPORT ON ACCIDENT TO ANDHRA PRADESH GOVERNMENT BELL 430 HELICOPTER VT-APG AT RUDRAKODU HILLS IN KURNOOL DISTRICT OF ANDHRA PRADESH ON 02.09.2009

Type and Model	:	Bell 430
Nationality	:	Indian
Registration	:	VT-APG

c) Date of Accident : 02.09.2009

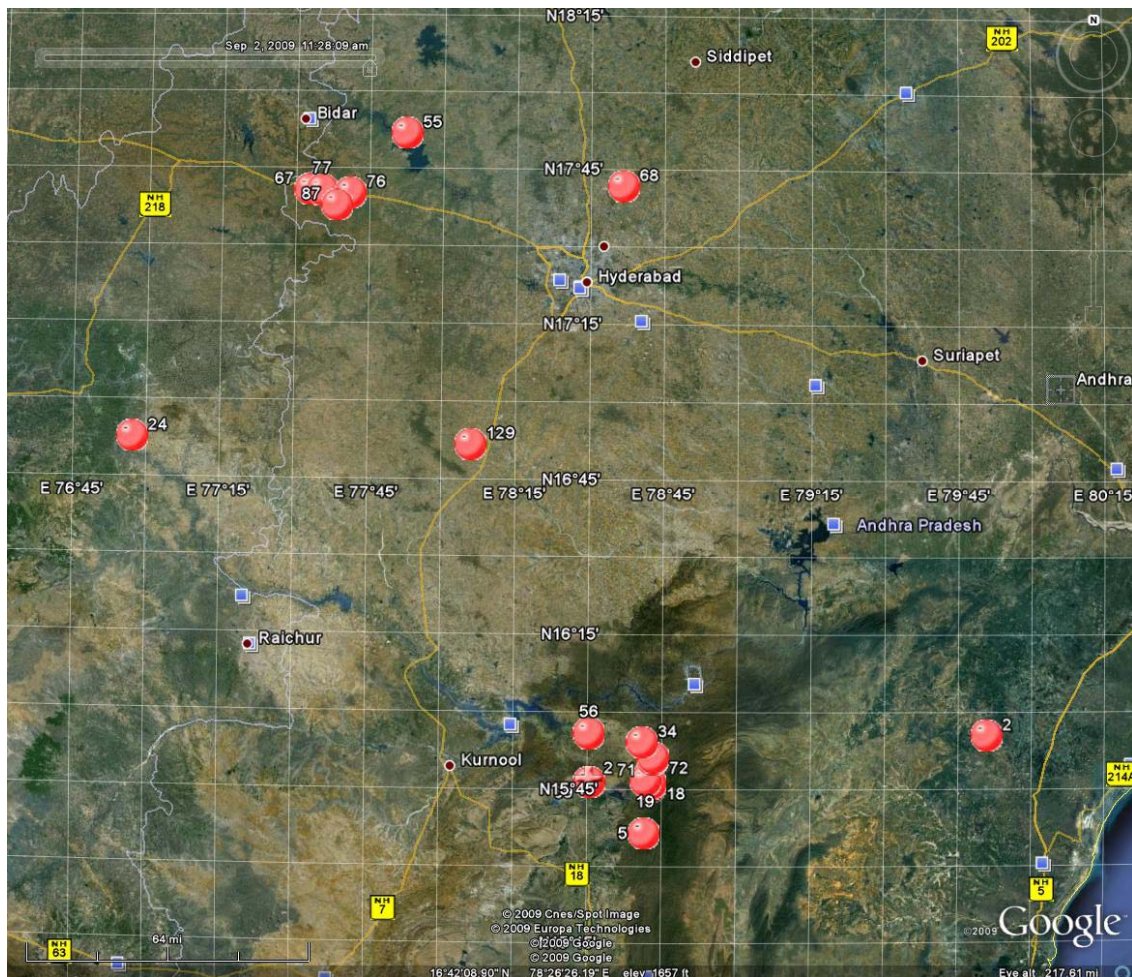
“A review of our archived lightning location data reveals a storm center that appears to be in the helicopters path at the time of the disaster which we believe was between 09:30 IST and 10:30 IST. **The first lightning activity that was reported in that area was around 09:00 IST, this data also located lightning at 09:35 IST in the area of the crash site.**”

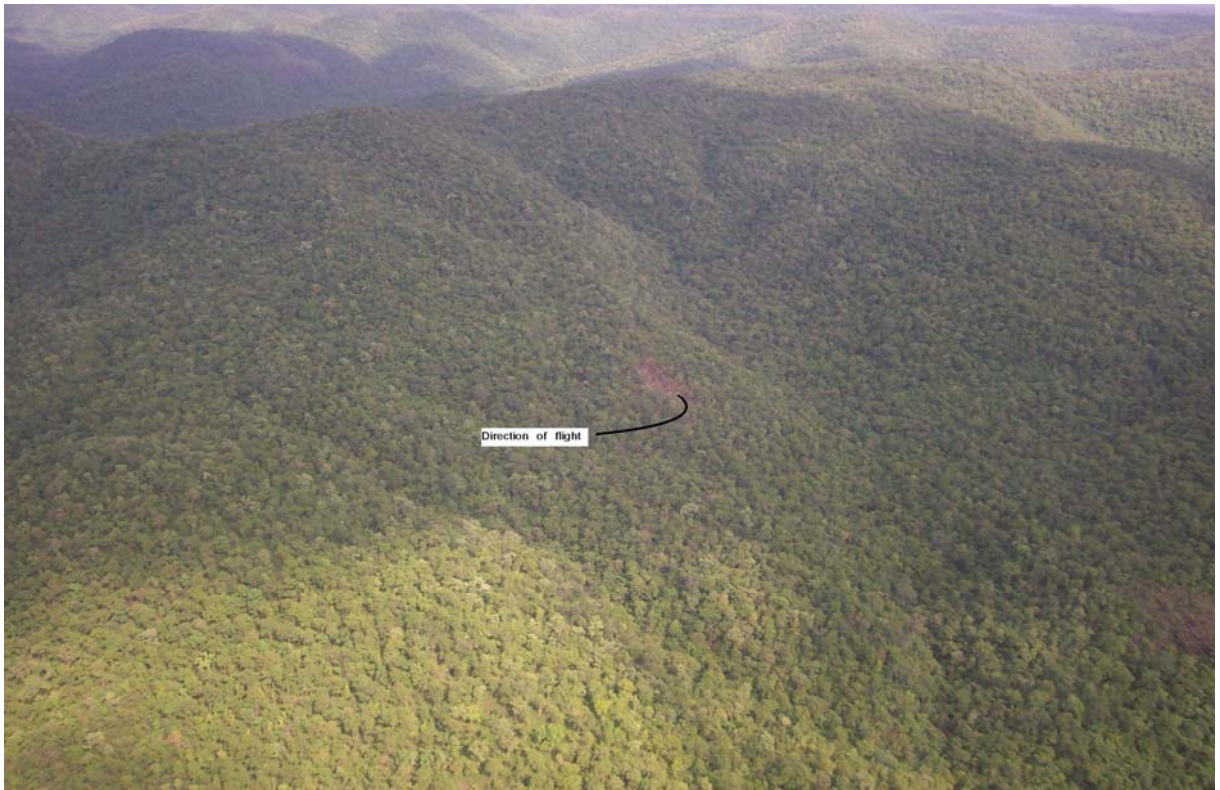
Aerial View of Accident Site

Accident site is approximately 26 km from Atamakur in the dense forest. The coordinates of the accident site are N 15° 47'04.7", E 078° 42'40.9". Accident site is at the slope of a hill. The surface is rocky. Due to impact the helicopter had

broken in number of pieces. The wreckage was spread over an area of 566 sq m. Helicopter approached the accident site in steep left bank.

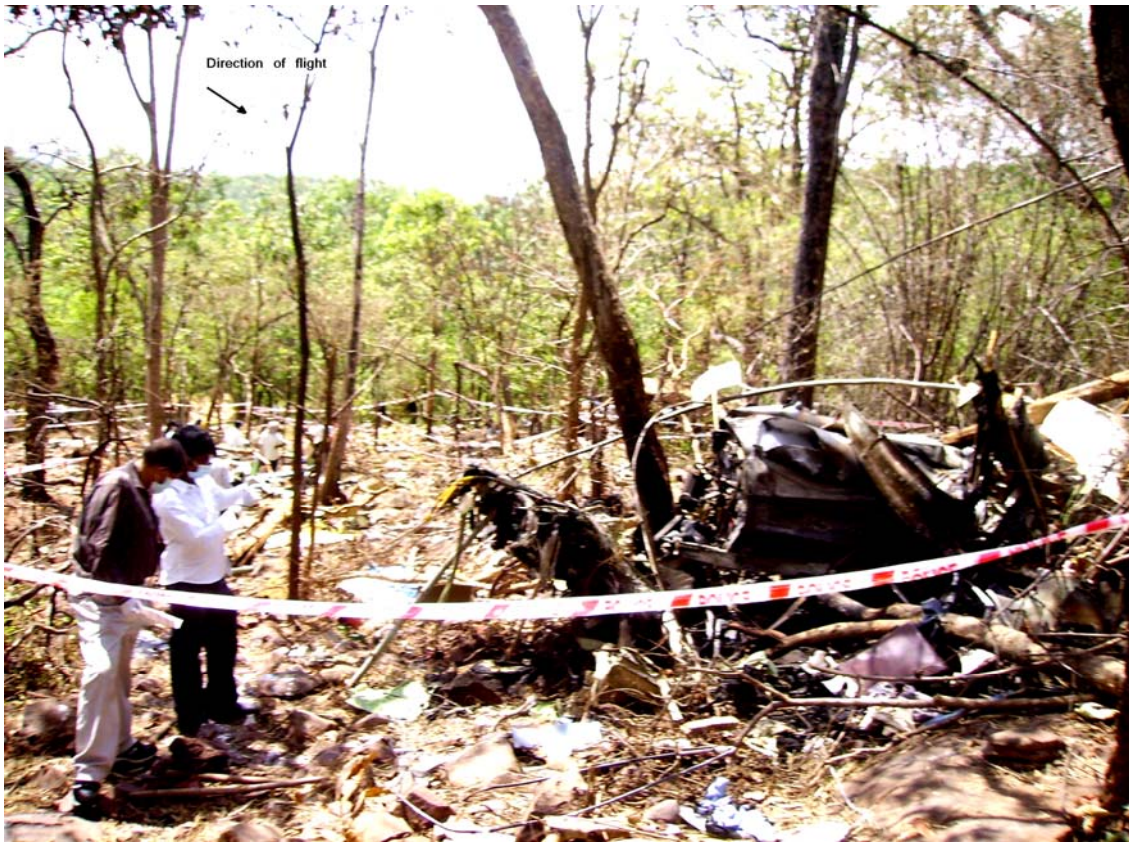
View of the site with direction of flight

At approximately 63 meters before the final resting point of main wreckage, the lower portion of the helicopter chopped off the tip of a tree around 40 feet in height. There after it moved forward in the same direction while losing the height and at 48 meters before main wreckage, the main rotor hit four trees almost in a row, on left, right and the body of the helicopter impacted trees in the middle, this is indicated by the damage on the trees. Portion of main rotor blades were recovered near them. From the central tree at approximately 6 meters in the forward direction the helicopter impacted the ground. The helicopter impacted the ground in steep left nose pitch down attitude. After the impact the tail rotor assembly along with vertical fin and a portion of tail boom separated and went towards right side. The PIC body along with the wire loom, portion of instrument panel, few instruments, torn floor mat with structural part, broken control sticks, and right cockpit door separated and were observed on the left of the path. At 22 m. before the main wreckage the helicopter passed through two trees. The right horizontal tail surface struck

the tree on the right and this portion of the tail boom separated from the helicopter. The Copilot body was further on the left along with the frame of the seat. At 15m from this point, Left wing upper portion, burnt VIP seat, and “passenger no.1” body was recovered. The back of the body bore signs of fire burn. The right wing upper portion with soot deposit was recovered 15 m to the right of main wreckage. The helicopter moved forward, its parts progressively separated and finally came to rest after impacting a group of trees and caught fire. The main wreckage was resting on left side and turned by 90° to the direction of motion.

No aircraft part was recovered before the tree where the initial impact was made. Ground marks of fire/soot were observed from 22 m before the main wreckage on the tree and the stones. Marks of the fire were observed on the leading edge of the one tail rotor blade, left horizontal stabilizer, lower portion of tail boom on the left and floor mat located near the horizontal stabilizer. Detailed wreckage diagram is given as appendix ‘A’.

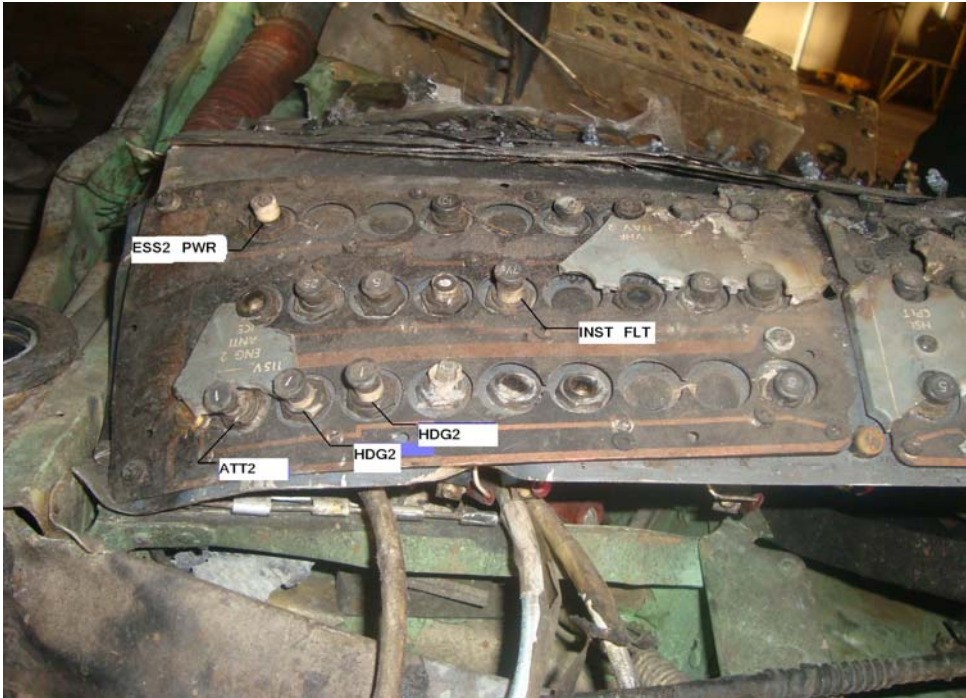
- c. **Position of switches and CB's**
CB's for "PED LIGHT", "ATT2", "HDG2", "ENG1 ANTI ICE", "INST FLT", "ESS2 PWR", "AUX FUEL TANK", "BAG SMOKE DET", "IIDS 1&2", "VHF COMM1", "FIRE EXTG BTL1", "FIRE EXTG BTL2", "FADEC

1&2”, “BUS INCON”, “GEN2 FIELD”, “GEN1 FIELD” were observed to be out.

Switches	Position
TEMP CONT	Middle
WSHLD WIPER	HIGH
ENG1 (FADEC)	AUTO MODE
ENG2 (FADEC)	MAN MODE
ENG2 (FIRE)	ARM

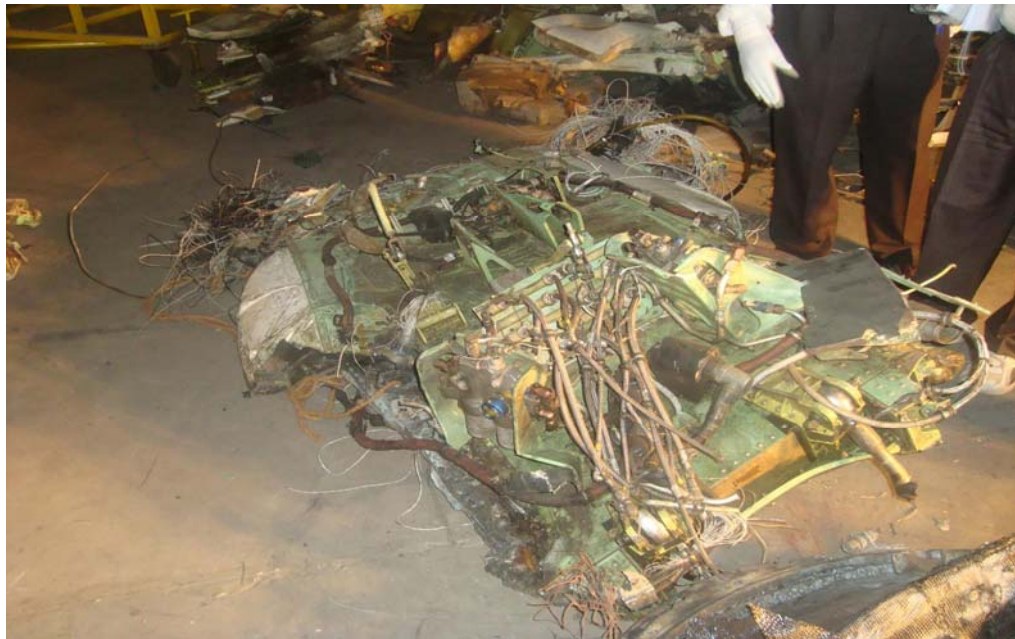
Transmission Deck

Transmission deck: both the hydraulic modules were intact. All the four manifold intact, all the hydraulic lines are connected. Three front and three rear Bell crank attachments separated.

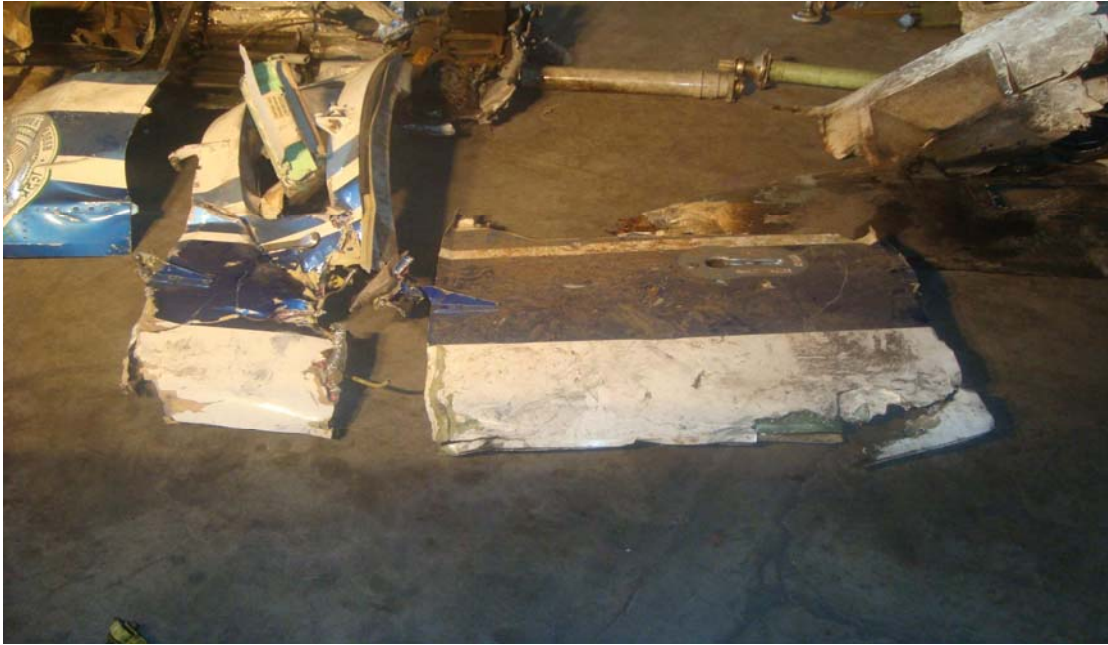
Doors on Right Side

Fuselage RHS: Cargo door fully recovered. Door is in locked position and separated from the fuselage. Passenger door glass with frame separated.

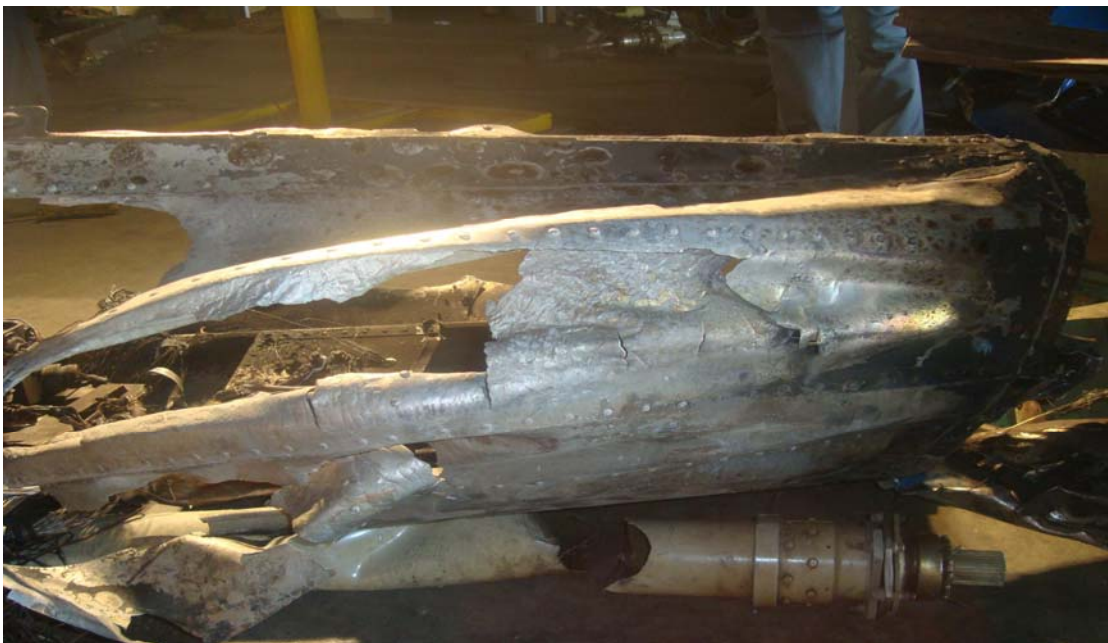
Aft fuselage portion with fire damage

Fuselage LHS: Passenger door was not located/shattered in to fragments. Fuselage portion from station 340 to 388 had separated from the fuselage and indicated severe fire damage.

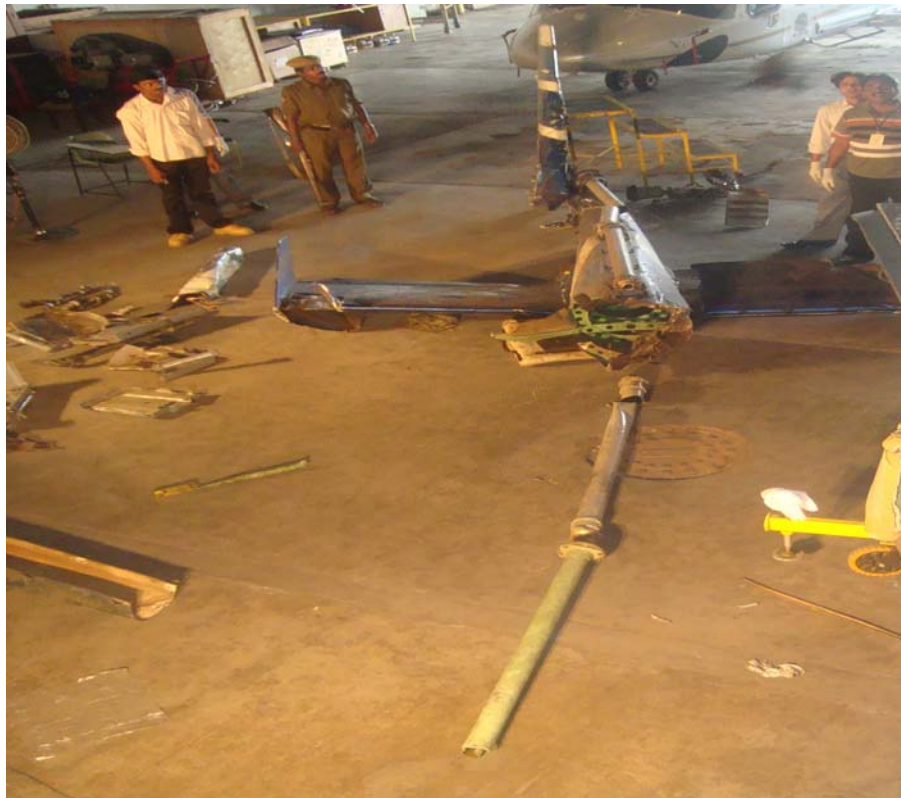
Tail boom and Tail rotor drive Shaft

Tail Drive Shaft: All the four segments of the tail drive shaft recovered. No.1 segment separated on the MGB side due to tear and torsion. Several scoring marks observed on the shaft. At the rear end the Thomas coupling is intact. None of the fasteners are adrift. Splines are satisfactory. No.2 Segment

came out from the spline. The inner splines are intact. Near the forward portion soot deposit and brown colouration is due to high temperature. On the rear, the shaft was ruptured. Splines are satisfactory and the coupling is attached. Third segment intact, attached at both ends and tail boom. No.4 Segment Split in two pieces. On the front end the coupling attached. Inner splines were found intact.

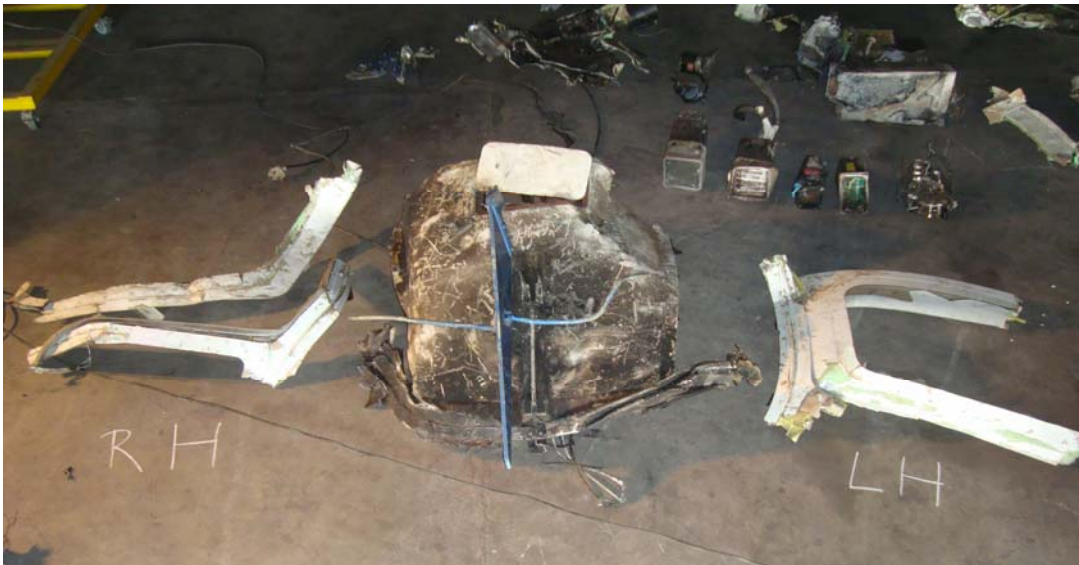
Cockpit doors with Upper Portion

The roof panel of the fuselage is deformed and bent inward due to impact from the front and left side. It is covered with soot. Only a portion frame of left and right cockpit door and frame was recovered. The forward edge of the right door is battered and bent outward in the forward direction. The lower portion of the frame is also bent in the forward direction. The left door is pushed in the backward direction. The frame is also buckled. Scissor assembly is damaged and separated. The damage pattern indicates forward and vertical impact on the left side and vertical impact on the right side.

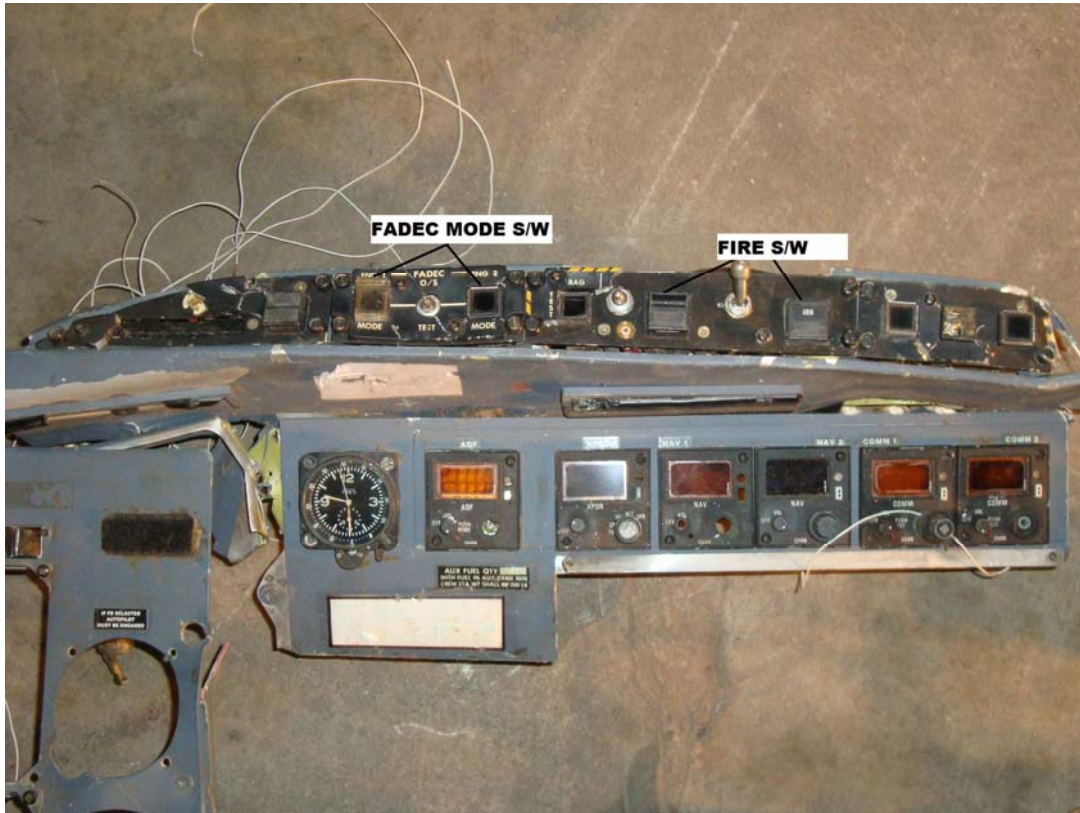
Glare Shield Panel

The glare shield panel indicates that the No.2 engine fire was armed. No.1 engine was in FADEC auto mode while No.2 engine was FADEC manual mode.

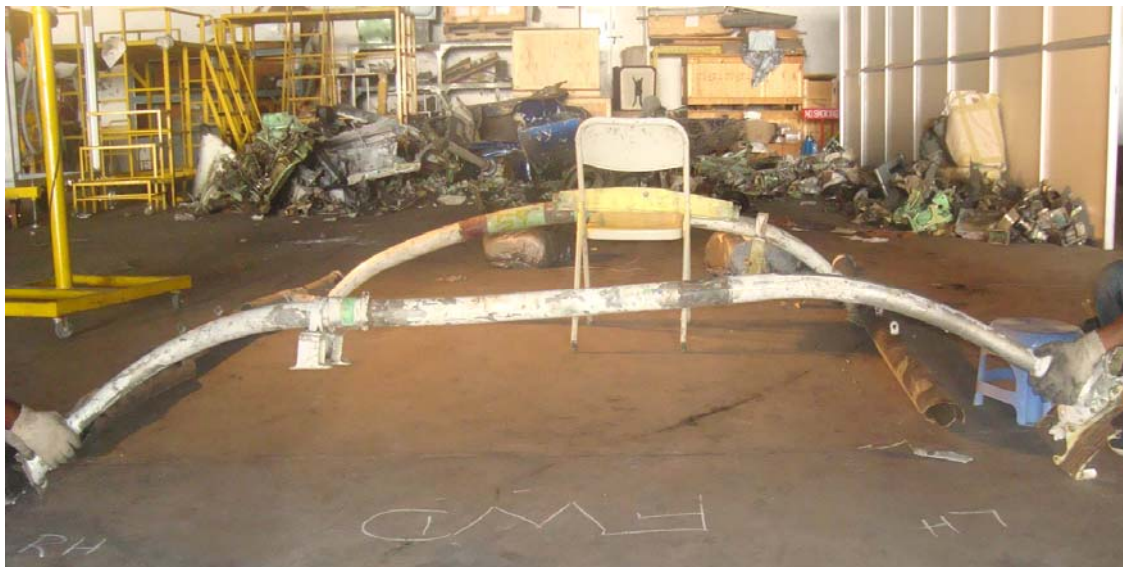
- Skid gear separated from the fuselage at the attachment points.
- Forward Cross tube on the left side was flattened and attachment to the skid was severed and twisted backward.
- Left Skid had severed near attachment at forward cross tube and aft cross tube and broken into three pieces.
- Right Skid was broken into five pieces.
- Aft cross tube support beam shifted towards the left.

Damage to the landing gear indicates that heavy impact was felt on the left side in the vertical and longitudinal direction which caused the flattening and twisting backward of the forward cross tube on the left side.

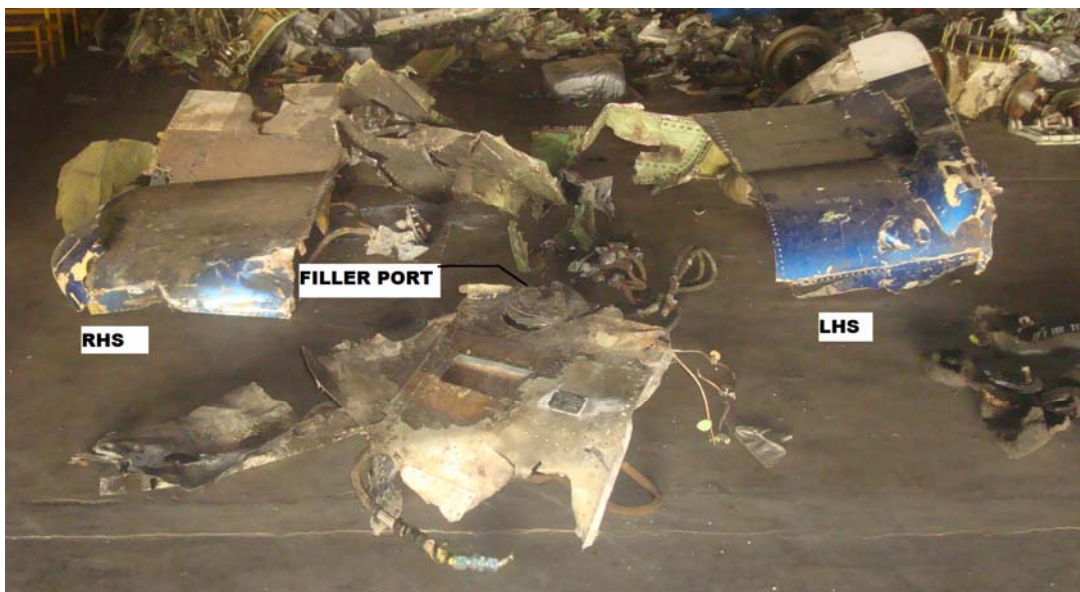
Only upper portion of the both wings were available. Soot deposits were seen on the underside of upper panel of the right stubwing. The panels had impact marks/penetration on the leading edge. Rear spar of both the stubwing tanks were in position though deformed. Flexible tanks had separated and torn in pieces and found in partially burnt condition. On the left side flexible tank attaching bolt were dislodged with elongation of the bolt holes inward.

Left wing fairing separated at the bolt line. Holes failed in the inward direction. Central fuel tank rear spar was available and showed signs of severe burns on the right side. Main tank and auxiliary fuel caps were recovered. Auxiliary fuel tank was totally burnt. Both sides of wing tip fairings have shattered in pieces.

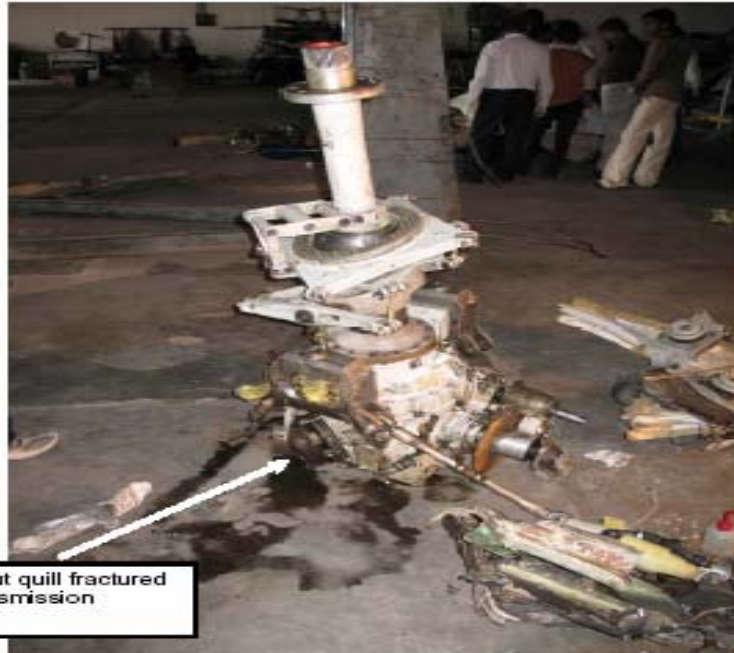
Left Aft View of Transmission

The swash plate and controls were attached to the mast. The left side input pinion had fractured from the transmission assembly due to overload fracture of the case.

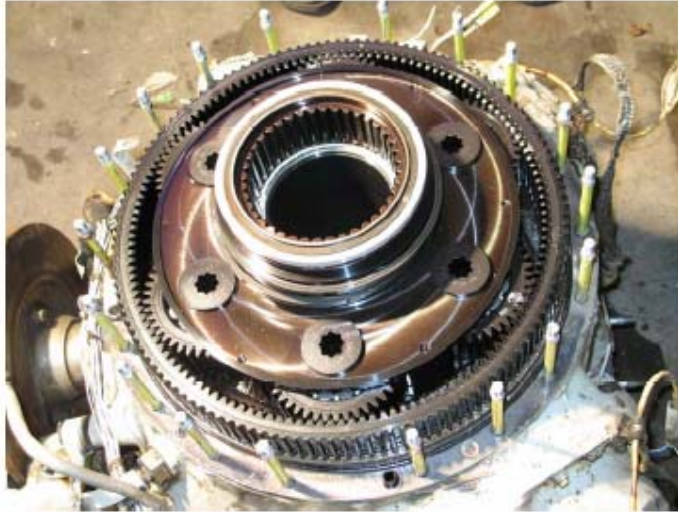
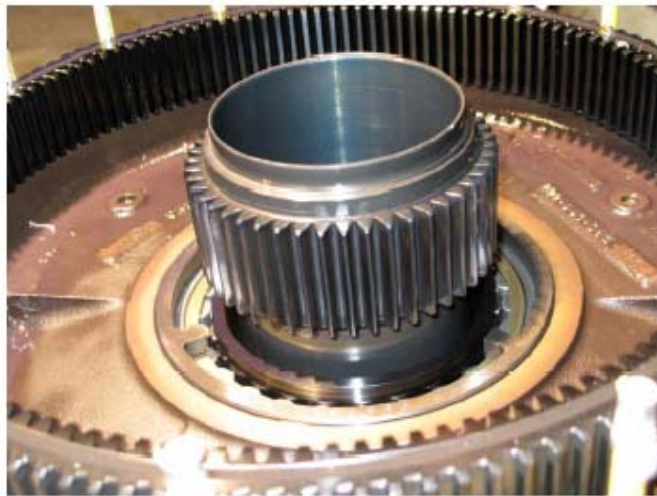
The transmission gears were in good condition. No evidence of degradation due to lack of oil pressure which was observed. The gears in the transmission were capable of smooth transmission of power.

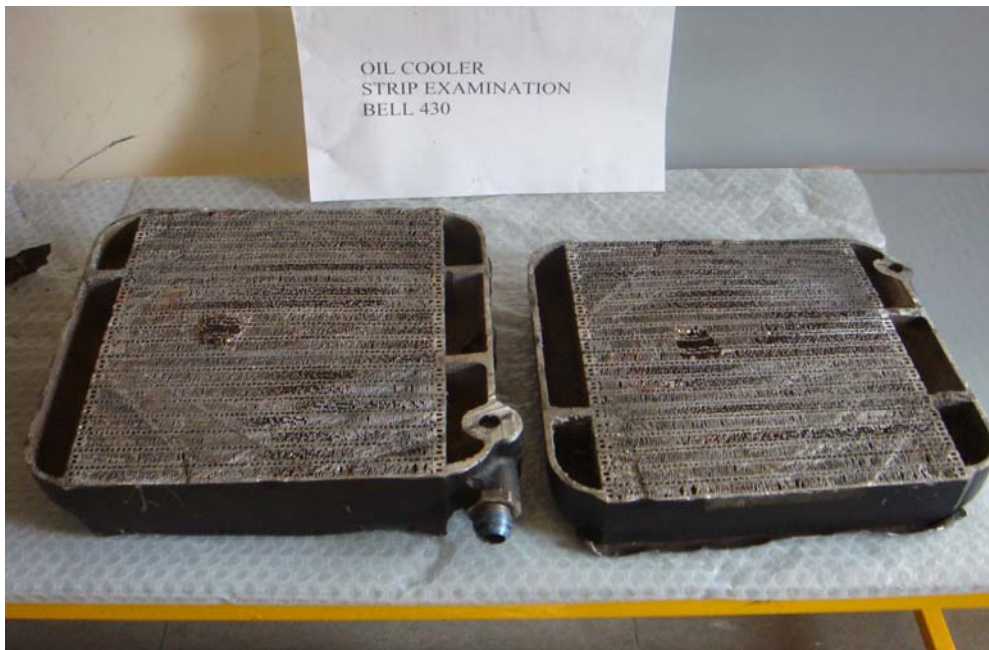
The transmission and engine oil cooler was cut open to check for any abnormality in the oil cooler. However, there was no sign of blockage, fire and any other abnormality which could be associated with the transmission oil cooler.

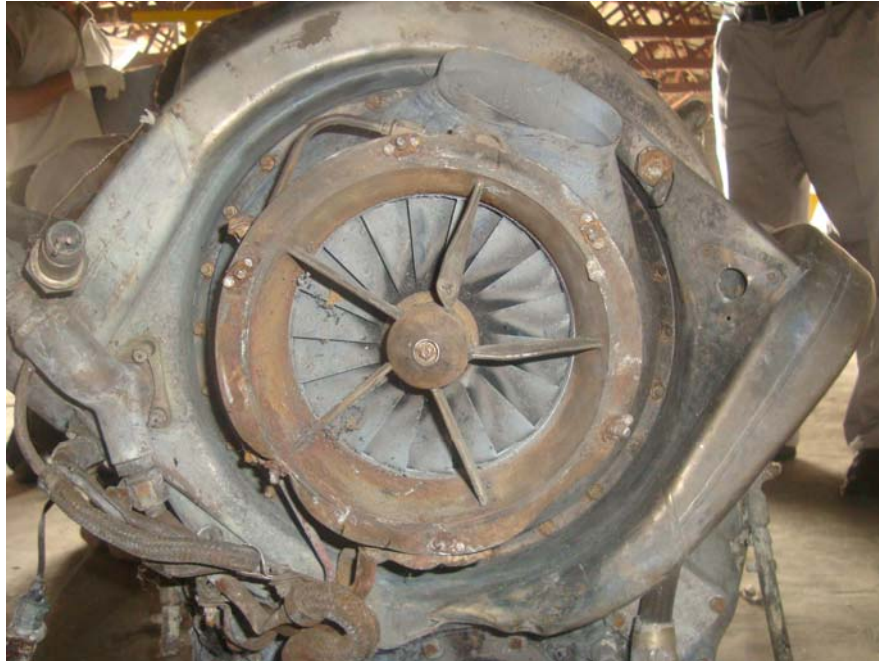
View from the front

The engine was recovered in the engine housing. It exhibited impact damage and fire damage. The compressor intake had fire damaged.

- a. Two compressor support struts had sustained frontal impact damage. No.1 lubrication line was intact. None of the compressor blades exhibited impact or foreign object damage. Diffuser vent pipe in place no rupture seen. Discharge tube was in place and no rupture seen. Main Drive Shaft was broken. AGB housing is burnt and broken on the forward bottom right side. N2 pickup is bent though in place. N1 pickup was in place.

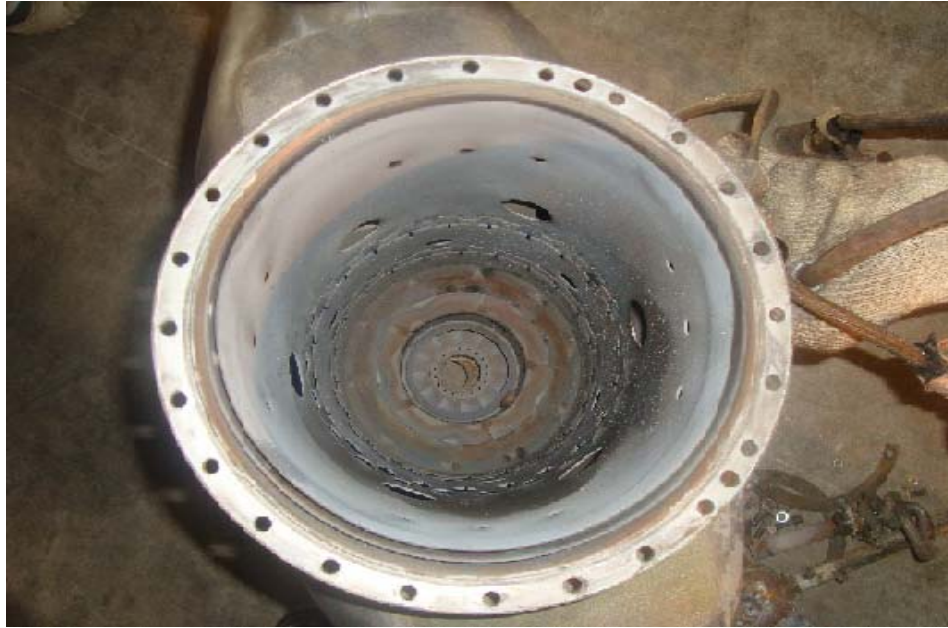
Combustion Chamber

Liner displayed no sign of operational distress. Inlet vanes were in satisfactory condition. No elongation or crack seen in primary, secondary, tertiary holes. No distress, crack or metal deposit seen on the flame tube.

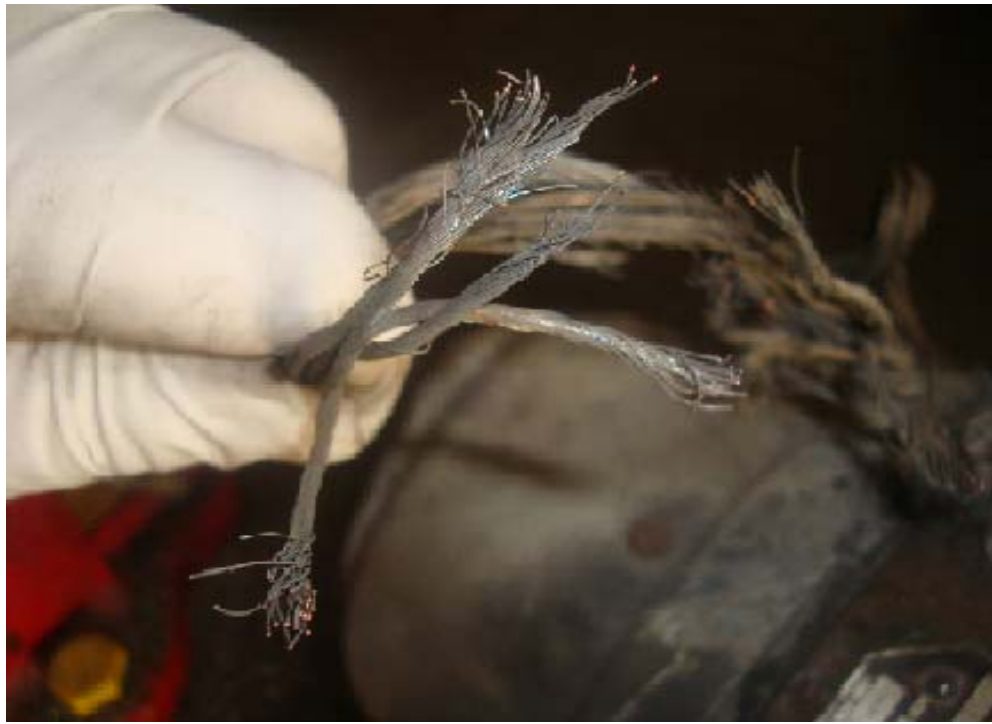
Electric Harness GEN. 1

Starter Generator: Soot deposit seen on mounting pad. Insulation of the electric harness was burnt and few electric harnesses were snapped and

showed formation of metallic bulb or deposit of molten metal at the broken end.
